SUBJECT: ELECTRONIC TYPEWRITER DIAGNOSTIC TOOL (XTDT)

SUBJECT: YOKE BREAKAGE — RIBBON CASSETTE CARRIER

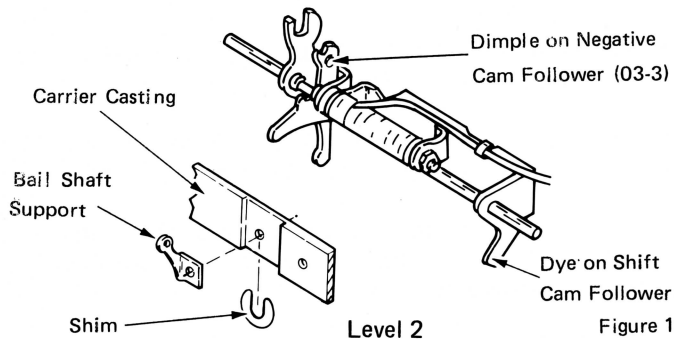
The negative cam follower (03-003) on the rack transfer bracket assembly (03-041) has been changed to improve negative transfer motion. The new level cam follower has a dimple on the upper right side, and new level bracket assemblies may be marked with blue dye on the shift cam follower (Figure 1).

These brackets do not require the shim (03-043) needed on old level steel brackets. The shim will no longer be included in the rack transfer bracket B/M.

Some new level rack transfer bracket assemblies have reached the field without any marking. To determine the level of the assembly, first ensure that all transfer-related adjustments are correct and hand cycle a negative transfer operation. Then watch for .015" additional motion of the negative cam follower after the rack detents to the front. If this motion is not present, install the shim between the bail shaft support (03-018) and the carrier casting.

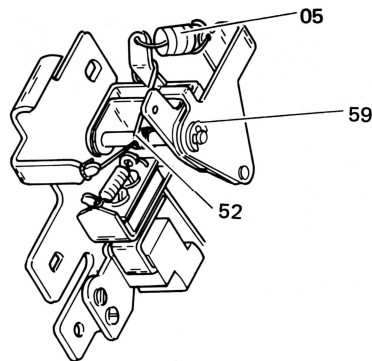
Figure 1

If experiencing piling, chugging (Model 50/60) or system busy (Model 75) install the redesigned knockoff arm return spring (06-52). This spring provides more reliable inhibitor restoring and increases the escapement magnet seal force. The old knockoff arm return spring should be removed and discarded.

To install the spring remove the C-clip (06-59) and slide the components on the stud to the left until the spring can be installed, then reassemble. The override spring (06-05) may be removed to facilitate installation.

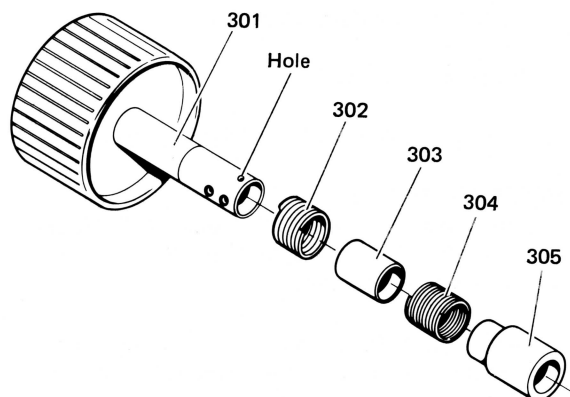
Figure 1

An override clutch has been added to the left end of the platen assembly. The clutch prevents index and alignment failures caused by inconsistent drive in the index mechanism.

1. Remove and discard the left platen knob (22-301), left bushing (22-305), and the washer between the index emitter wheel (23-20) and the c-clip (23-21).
2. Insert the extension of the override spring (22-302) into the hole in the new platen knob shaft (Figure 1).

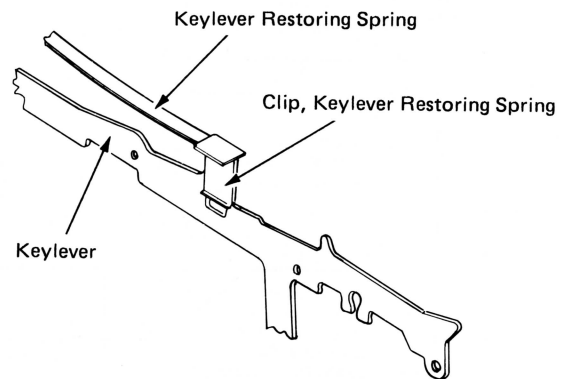
Figure 1

A single operation keylever restoring spring clip (21-85) and a repeat operation keylever restoring spring clip (21-86) are now available for use on Electronic Typewriters Model 50/60/75. These clips will prevent the keylever restoring spring (21-74, 80) from slipping off the keylever.

When installing either clip remove top section of the keyboard (21-084). To install a single-operation keylever restoring spring clip, slide the flat part of the clip on the restoring spring first (Fig. 1).

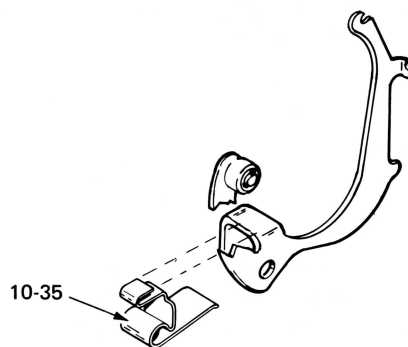
Figure 1

A cycle clutch latch support has been released for field use. This support will reduce PSCC extra cycles caused by the latch not holding the sleeve.

To install the support, remove the print shaft belt, the PSCC backcheck pawl (10-44) and the restore arm (10-71). Slide the support onto the restore arm (fig. 1) and re-install the restore arm (fig. 2), the backcheck pawl, and the print shaft belt.

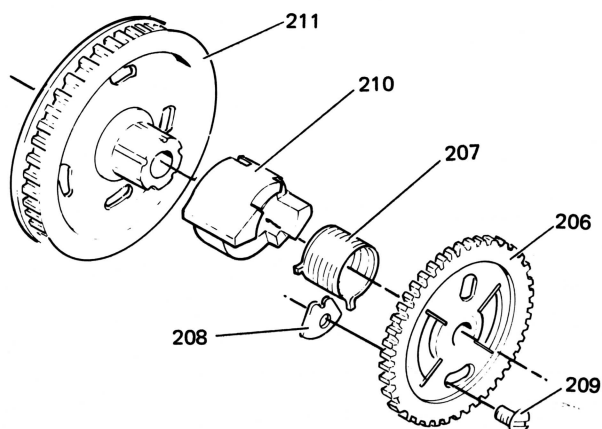
Figure 1

The width of the PSCC Gear (11-206) and the Print Shaft Gear (11-234) has been increased.

NOTE: The Print Shaft Cycle Clutch Spring adjustment has been changed to .030" - .055" (0.76 - 1.4 Omm).

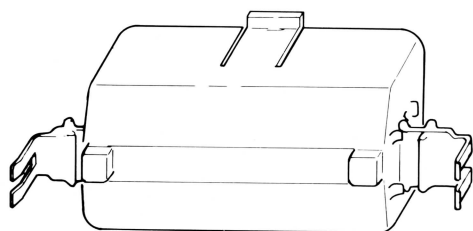
Figure 1

A new level carrier cable support box is now available for the XTDT-II. The thickness of the material has been increased and the cutouts on the left and right sides of the box have been removed, (Figure 1). These changes will prevent the box from separating from the XTDT-II board assembly during use.

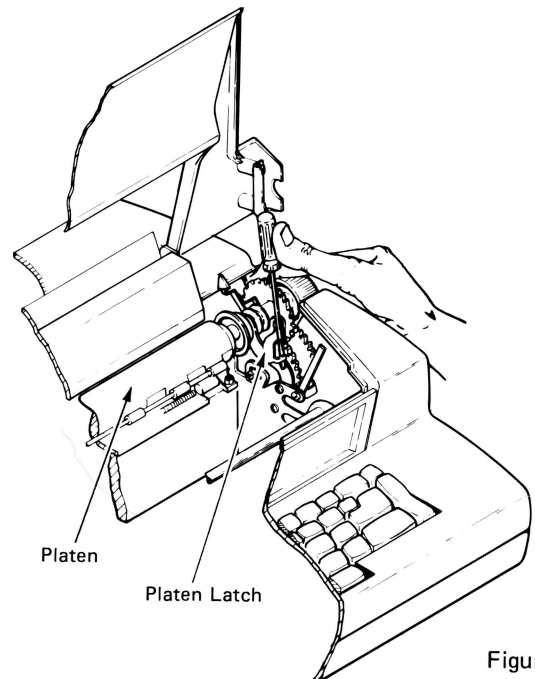
Figure 1

Care should be exercised to avoid trapping a finger between the RH platen latch and the top cover when removing the platen. Either of these suggested procedures may be used to remove the platen:

- A)
 1. Pull the platen detent release lever forward.
 2. Release both platen latches.
 3. Remove the platen.
- B)
 1. Insert the blade of a small screwdriver as shown in Fig. 1. (Note: Blade is positioned behind the RH platen latch stop lug.)
 2. Move the screwdriver handle to the rear, releasing the RH platen latch.
 3. Release the LH platen latch.
 4. Remove the platen.

NOTE: File smooth any rough edges found on the top cover in the area of the RH platen latch.
